**DRAFT ADDENDUM 1
REMEDY EVALUATION REPORT FOR THE
KERR-McGEE CHEMICAL CORPORATION SUPERFUND SITE
TRONOX FACILITY SODA SPRINGS, IDAHO**

March 1, 2009

GLOBAL ENVIRONMENTAL TECHNOLOGIES L.L.C.

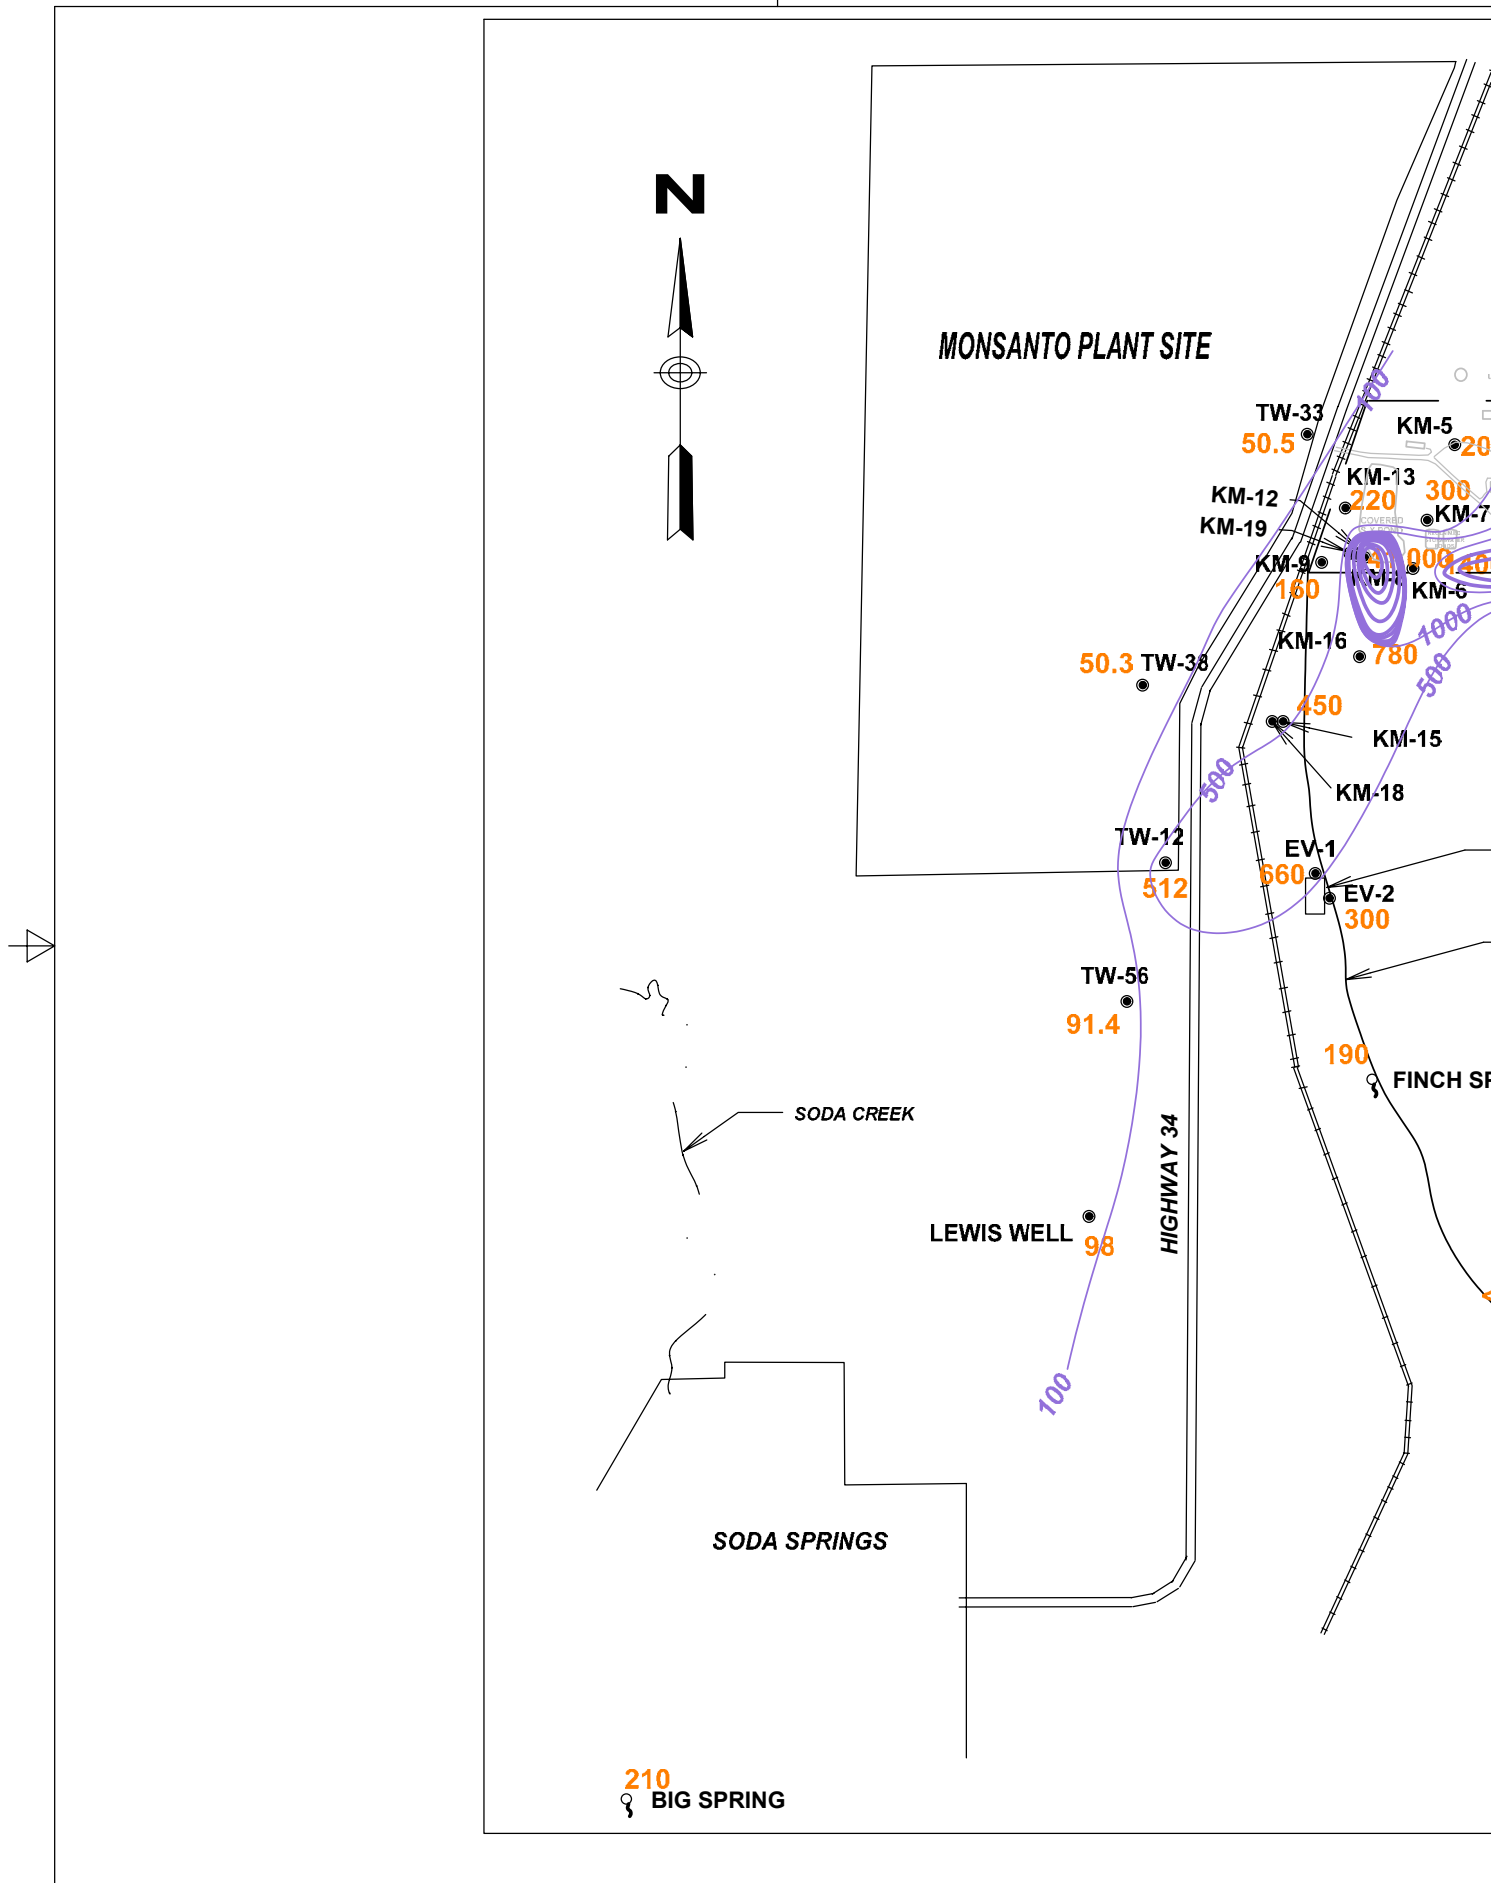
FIGURE 2-7

Manganese concentrations in ground water for May 2007 are shown on Figure 2-7 and extend from the west side of the former scrubber pond in KM-3 in a westerly direction
